Asbestos NESHAP & Lead Survey

Performed at:
Lake City VA Medical Center
619 South Marion Avenue
Lake City, FL 32025

OHC Project #160028-AL

**Re: Asbestos NESHAP & Lead Survey
Lake City VA Medical Center
Mechanical & Plumbing Improvements Project
Buildings 19, 38 & 64
OHC Project No. 160028-AL**

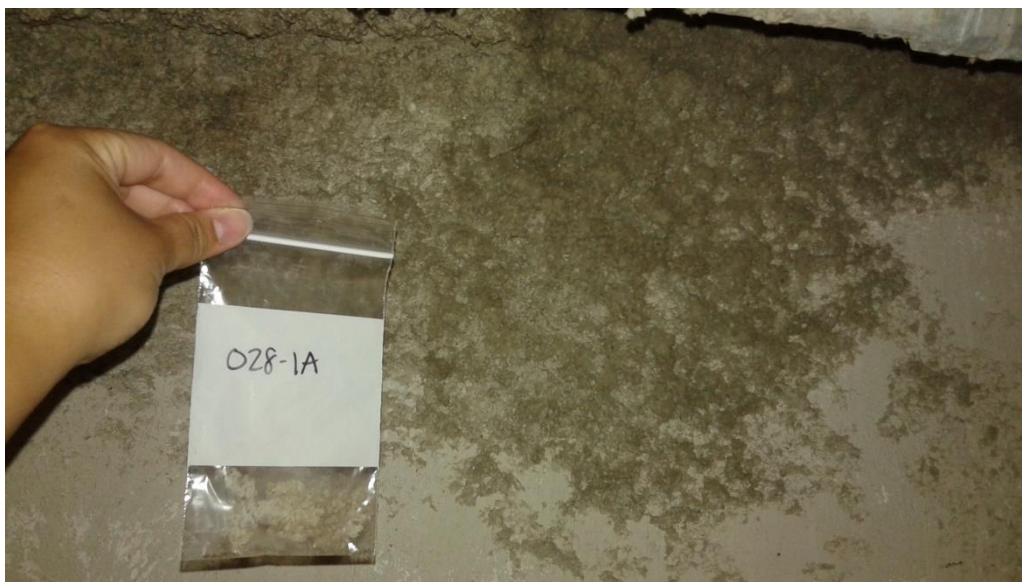
HSA-1
Gray spray-on fireproofing
[Building 64 Room BB26 – AHU-6 & AHU-7]

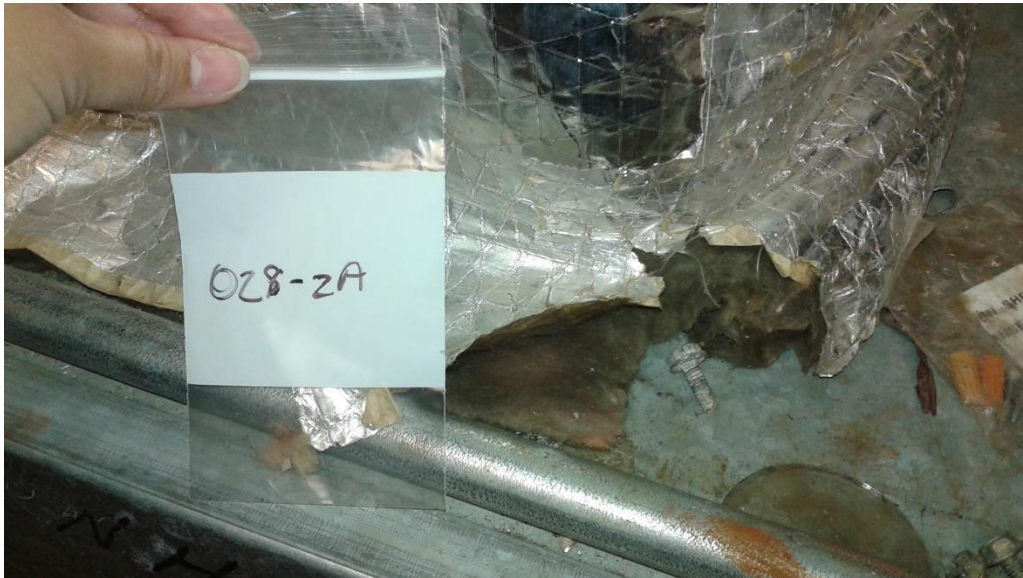
HSA-2

Flex ductwork associated with foil and tan fiberglass insulation
[Building 64 Room BB26 – AHU-6 & AHU-7]

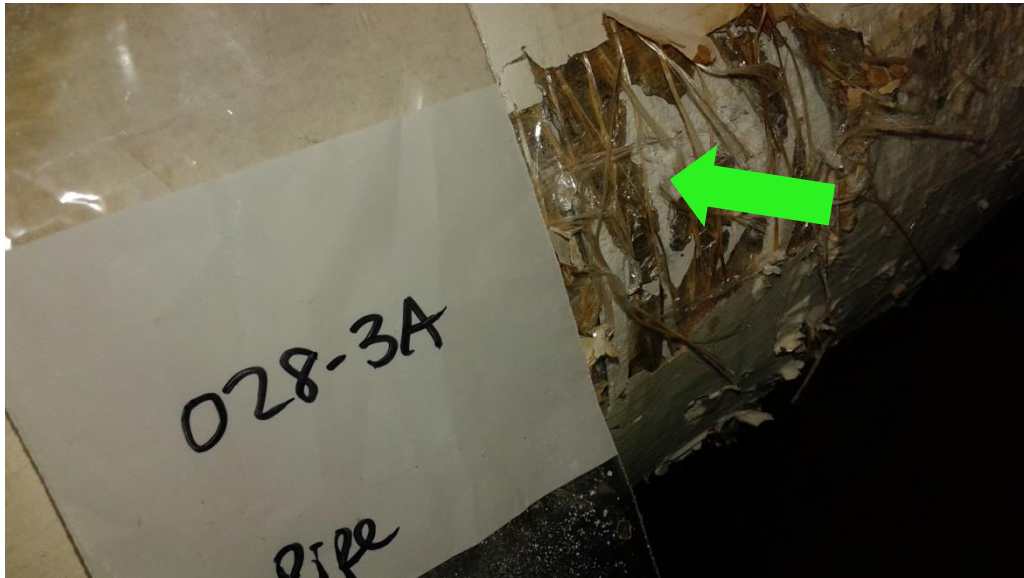
HSA-3

White coating beneath wrap associated with large water pipe
[Building 64 Room BB26 – AHU-6 & AHU-7]

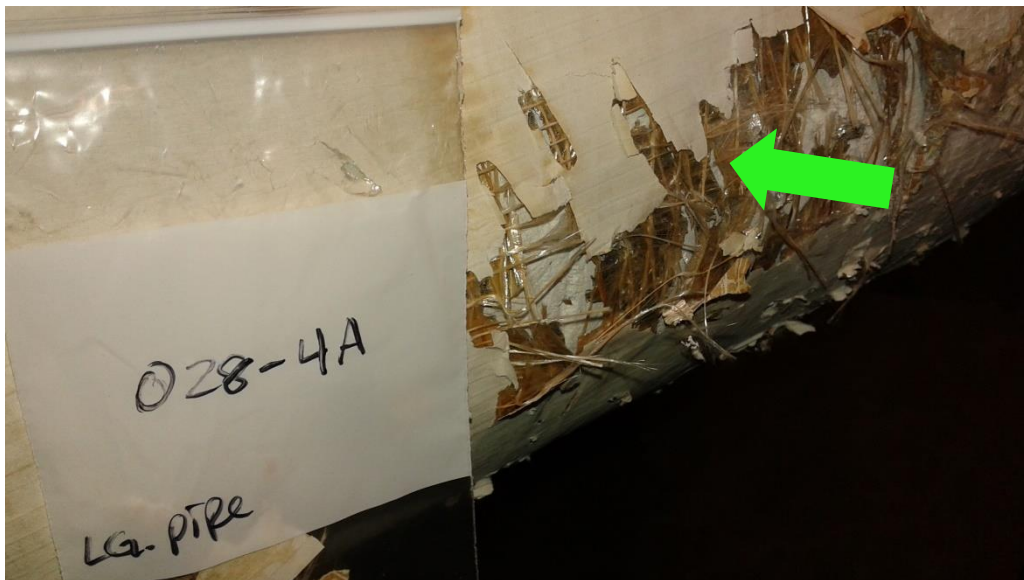
HSA-4

White foil paper wrap with fibers associated with large water pipe
[Building 64 Room BB26 – AHU-6 & AHU-7]

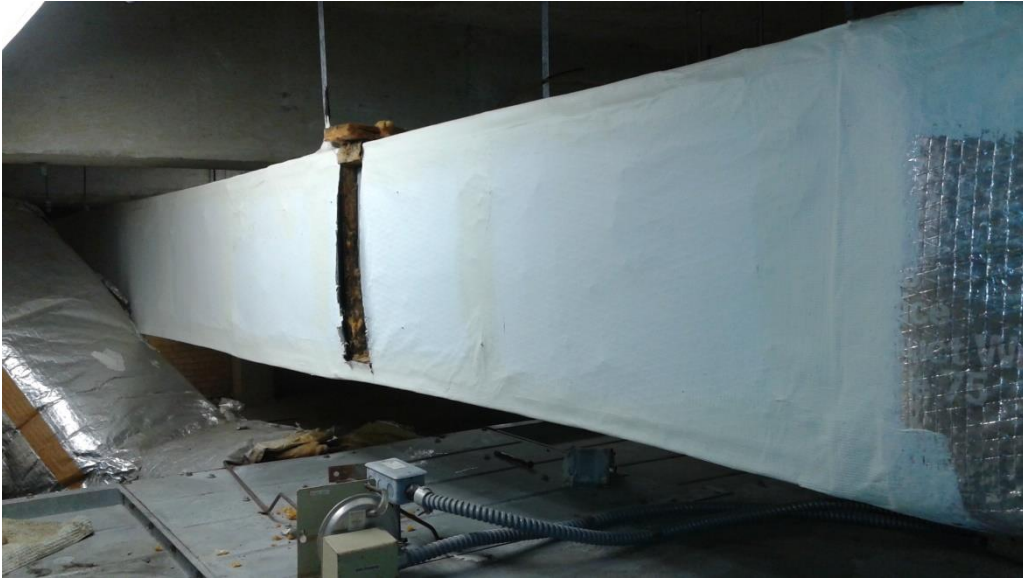
Square ductwork throughout Room BB26 in Building 64 containing
HSA-5 (ACM)

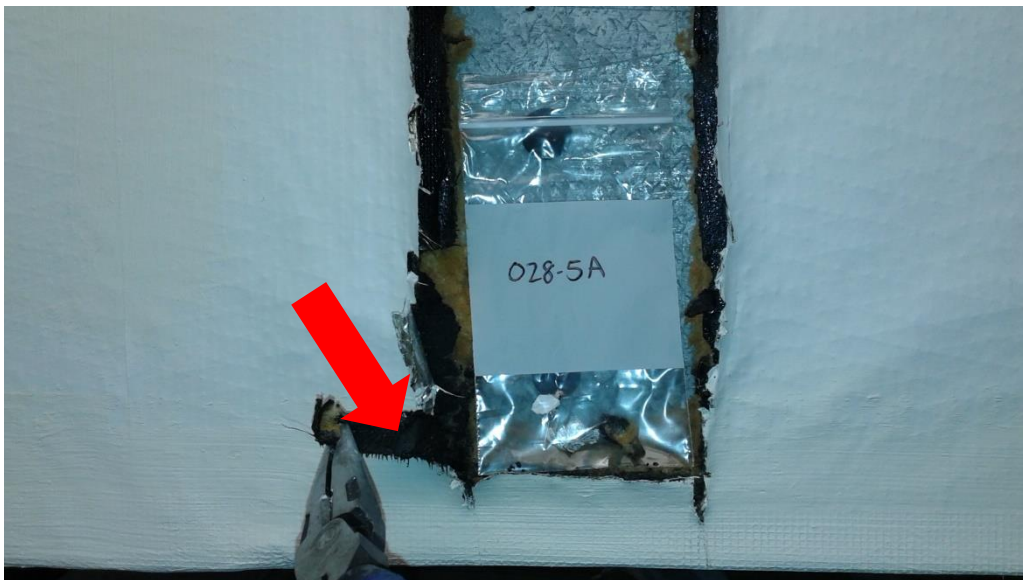
HSA-5
Black mastic associated with square ductwork
[Building 64 Room BB26 – AC-7]

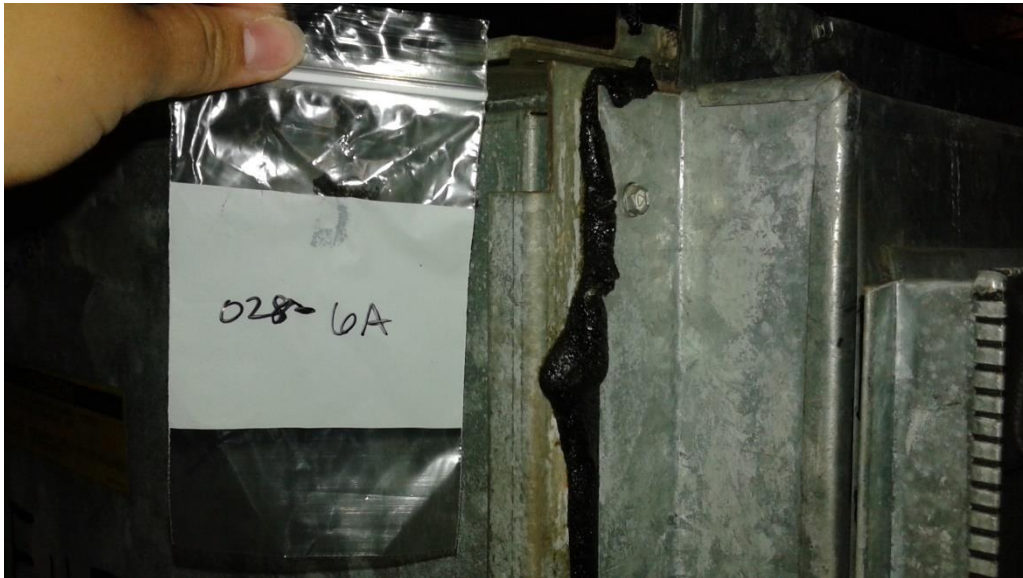
HSA-6

Black mastic around AHUs
[Building 64 Room BB26 – AHU-6 & AHU-7]

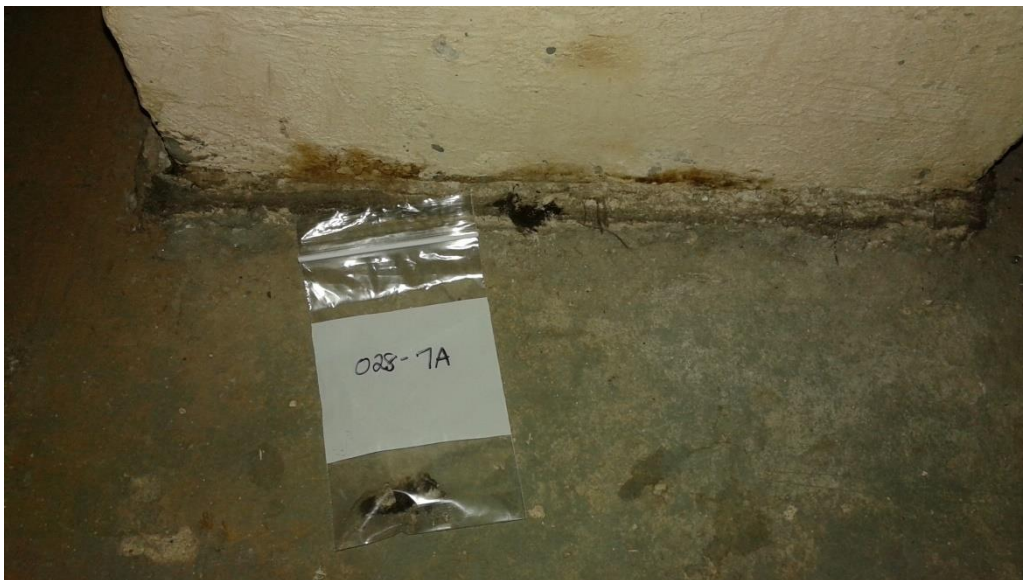
HSA-7

Black expansion joint around concrete columns ex ductwork associated
with foil and tan fiberglass insulation [Building 64 Room BB26]

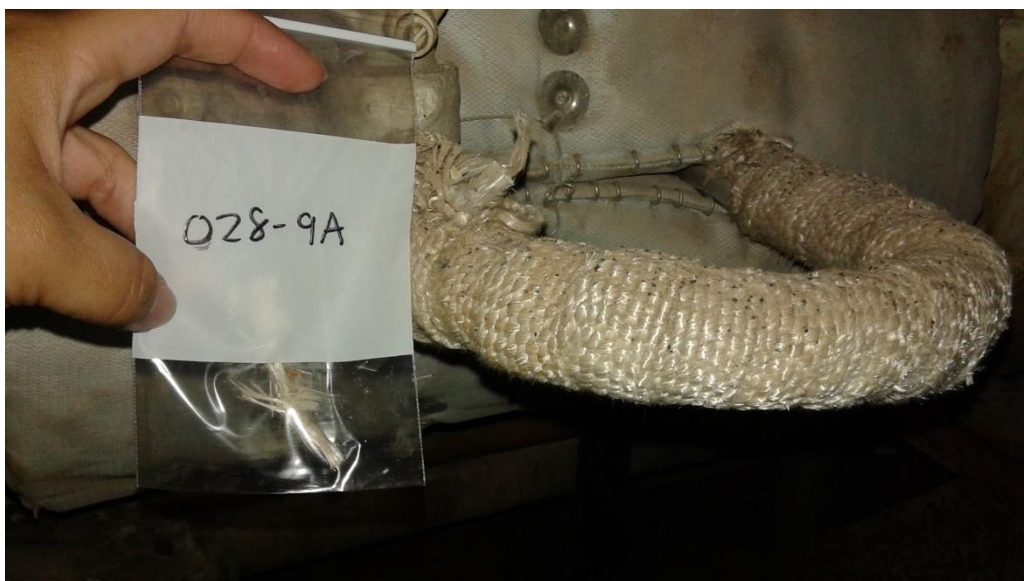
HSA-9
White fibrous hot pipe wrap
[Building 64 Boiler Room AB05B]

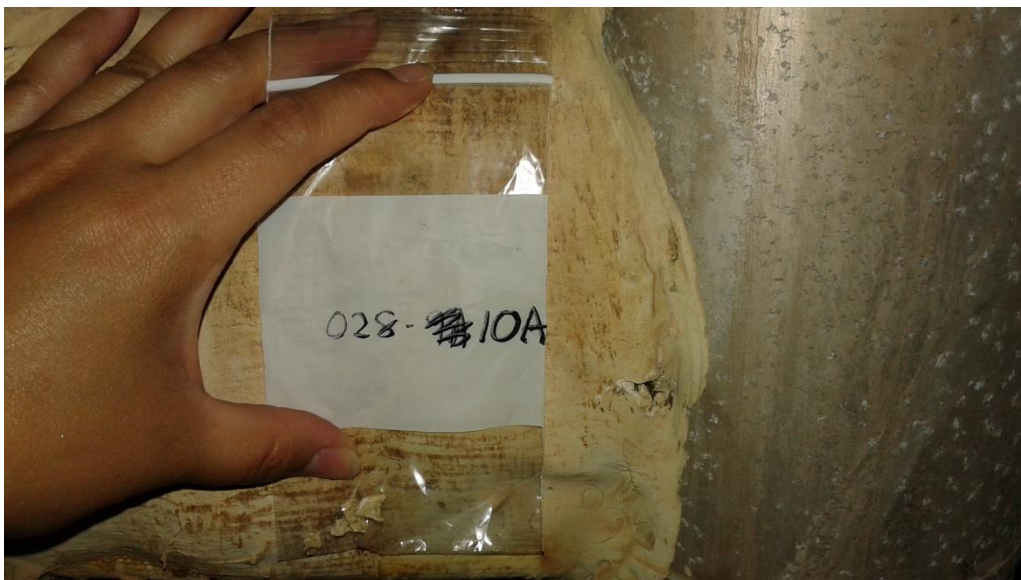
HSA-10

White mastic on steam water pipe ends
[Building 64 Boiler Room AB05B]

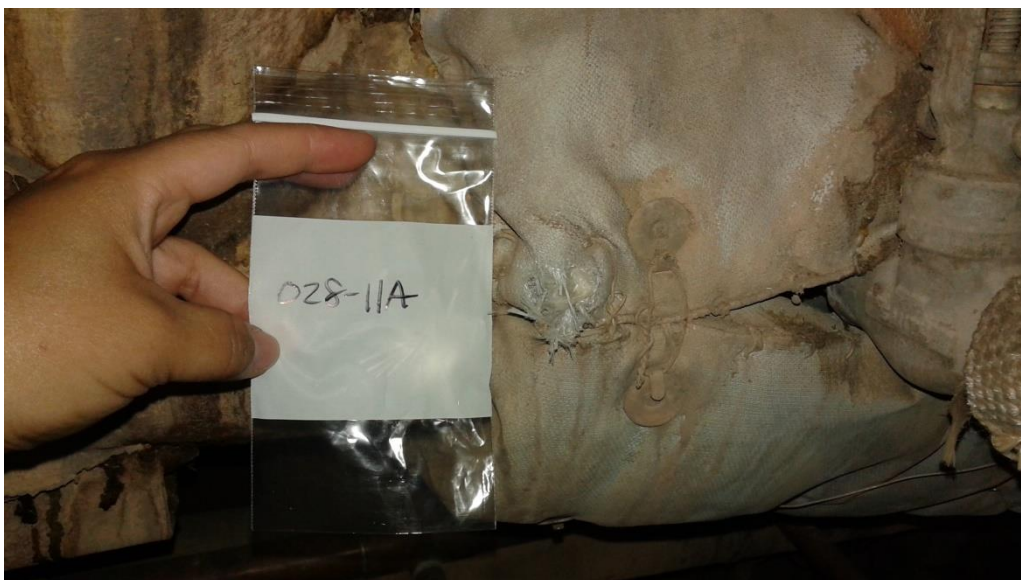
HSA-11

Gray wrap around steam water pipes
[Building 64 Boiler Room AB05B]

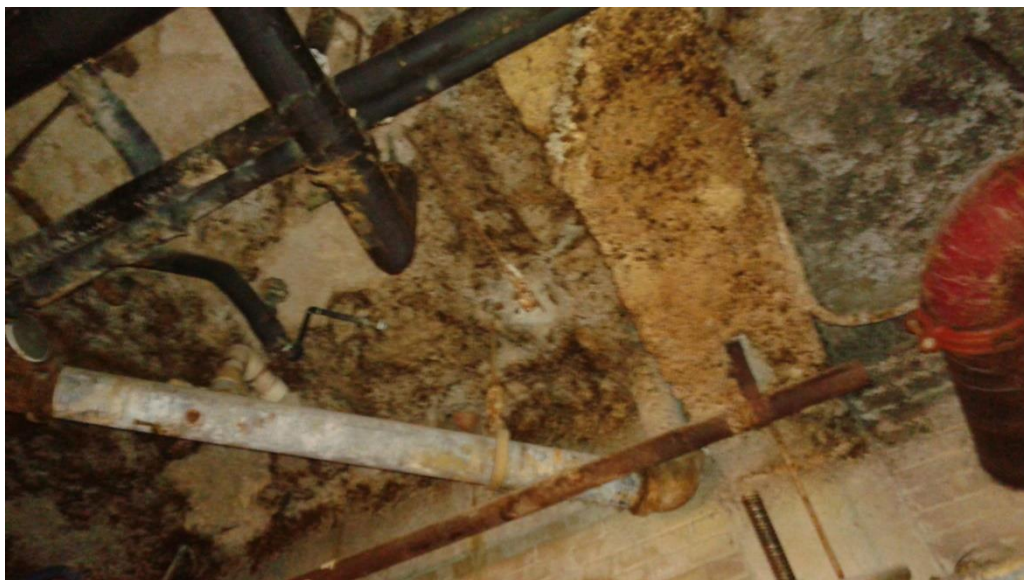
HSA-12

Gray spray-on fireproofing throughout ceiling
[Building 64 Boiler Room AB05B]

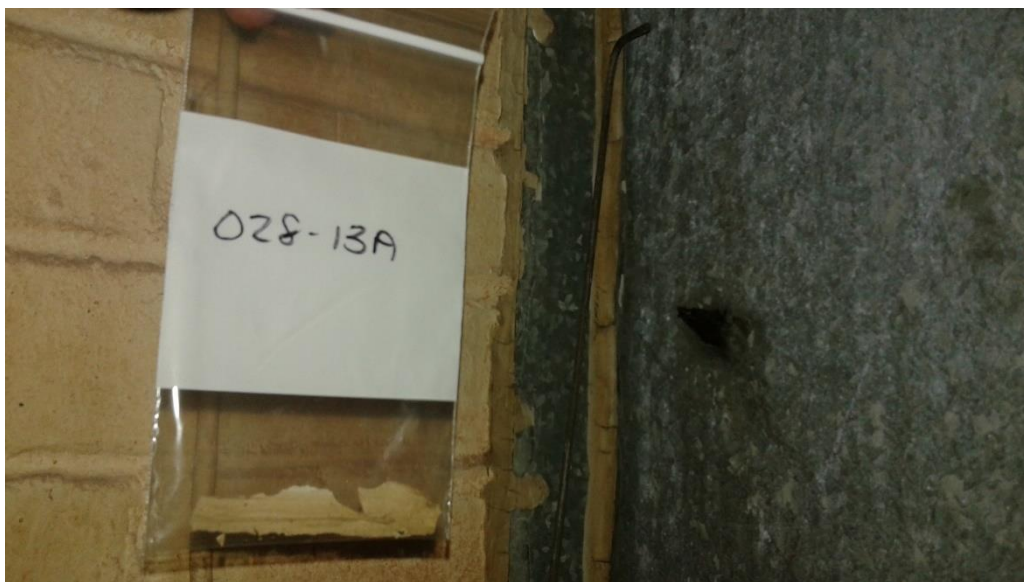
HSA-13

Tan caulking around AHU and concrete wall
[Building 64 Room AB05 – HV-013]

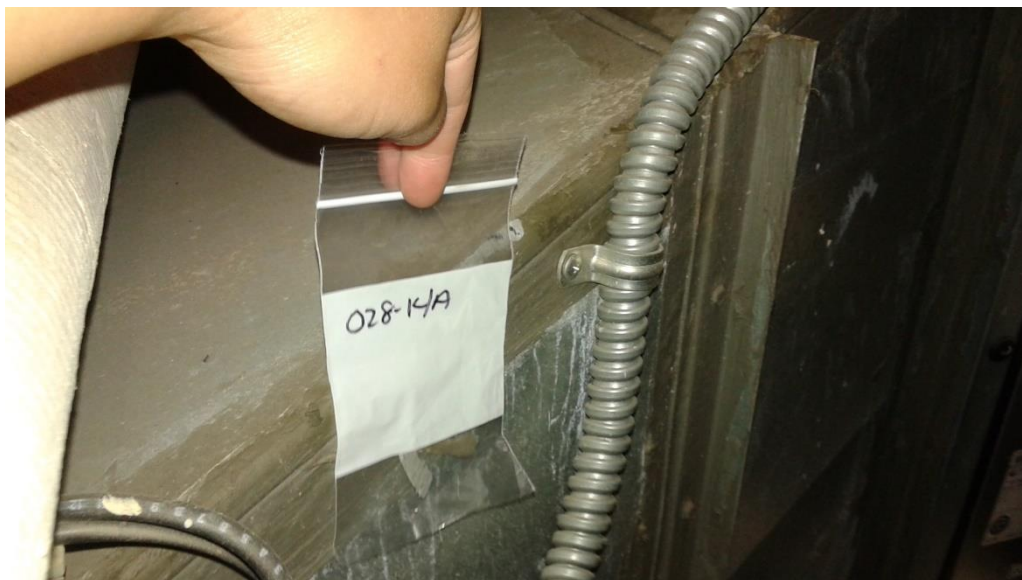
HSA-14
Gray mastic around AHU
[Building 64 Room AB05 – HV-013]

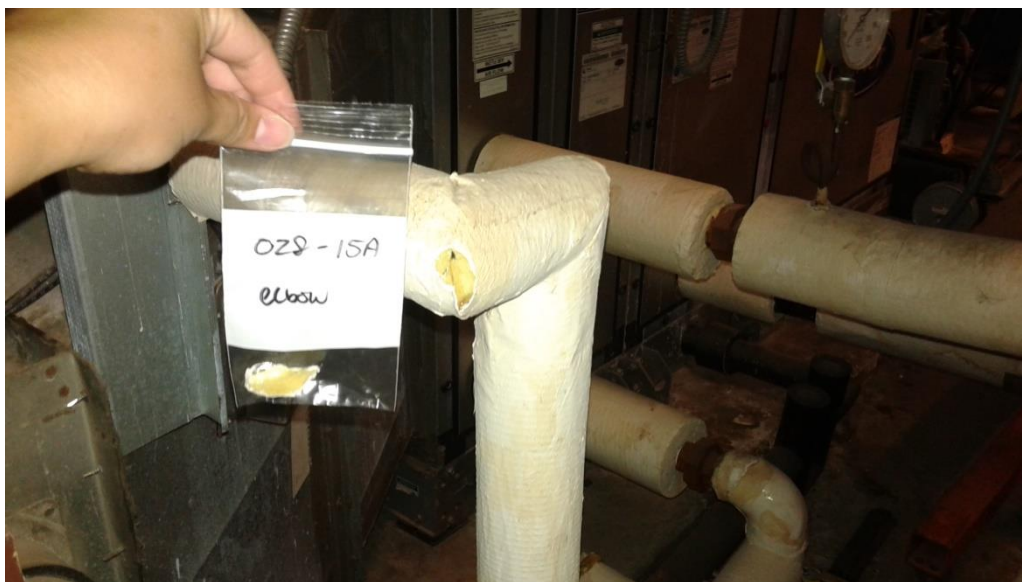
HSA-15
White mastic associated with wrap around water pipes
[Building 64 Room AB05 – HV-013]

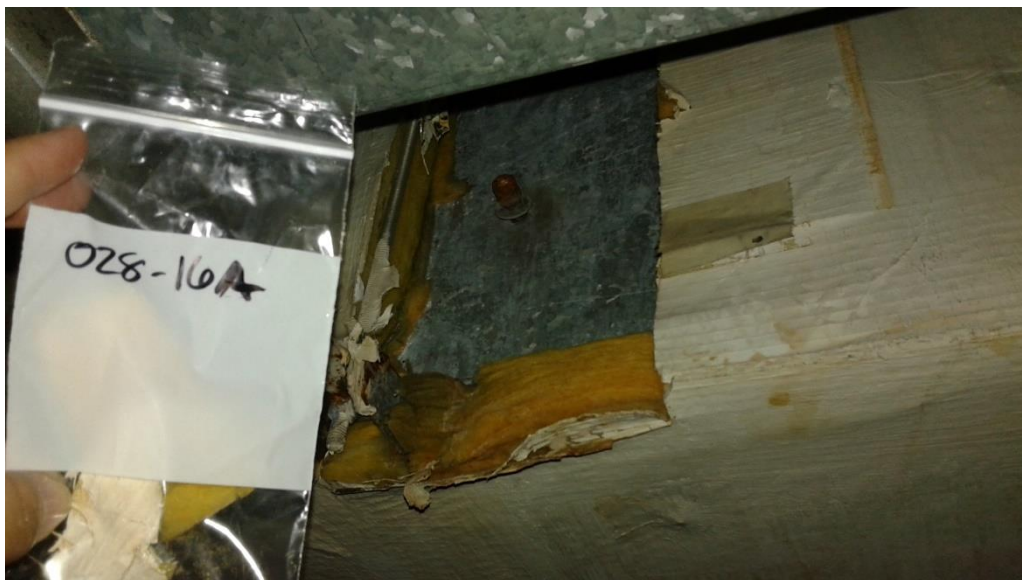
HSA-16

White duct wrap associated with yellow fiberglass insulation
[Building 64 Room AB05 – HV-013]

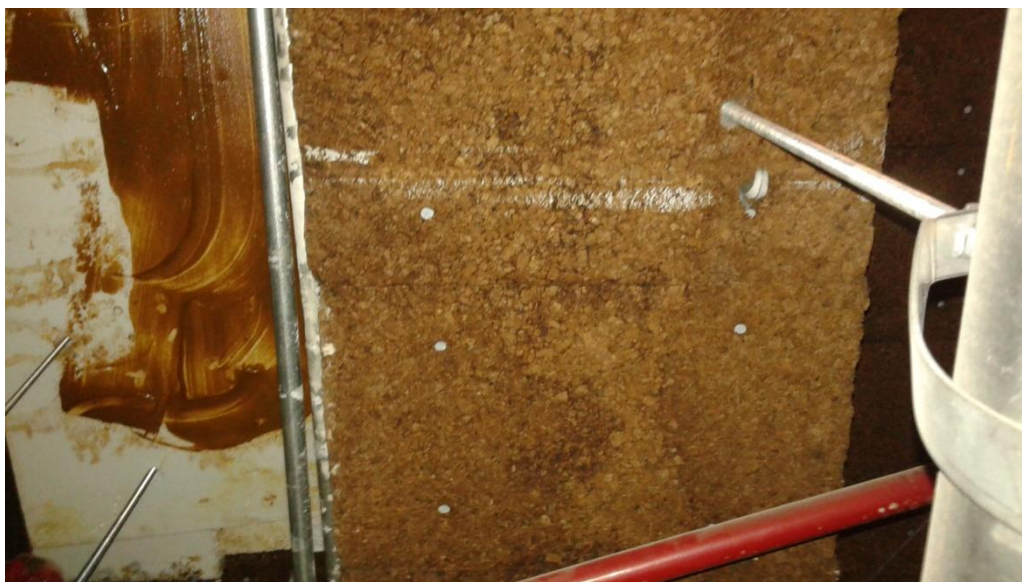
HSA-17

Brown cork-like ceiling sheets
[Building 64 Room AB05]

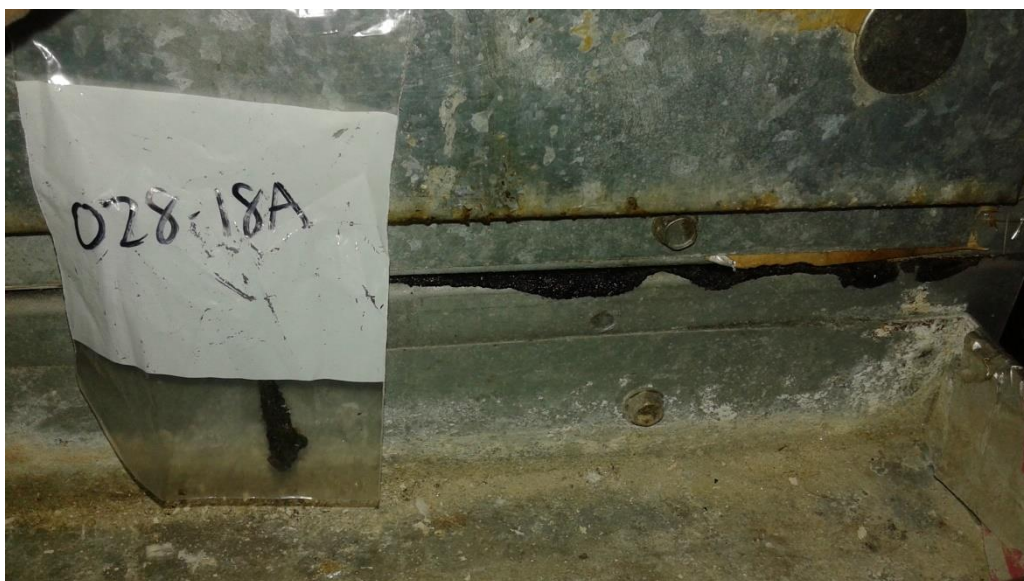
HSA-18

Black mastic associated with exterior metal AHU
[Building 64 Room AB18K – AC-12]

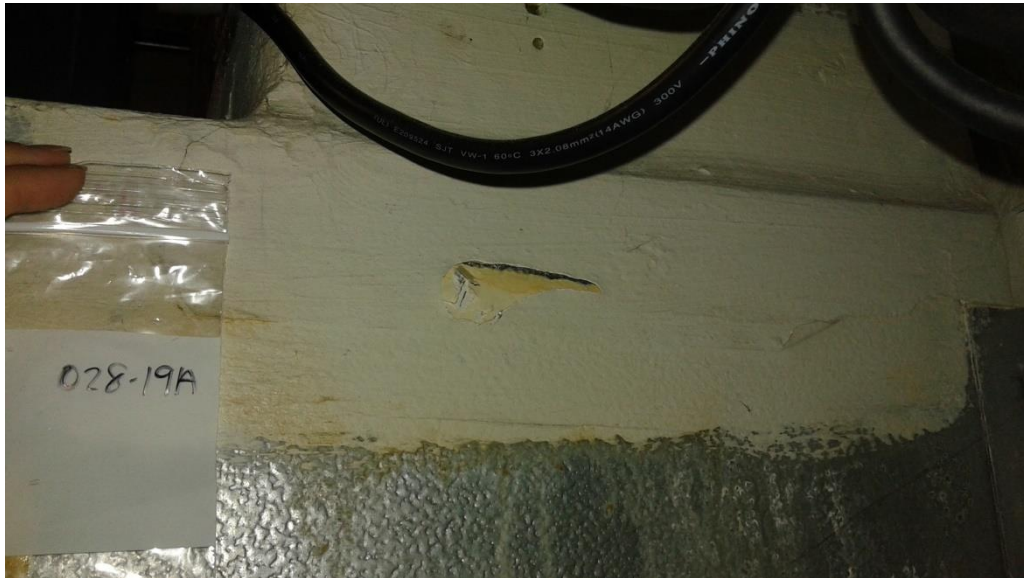
HSA-19

White mastic associated with exterior metal AHU
[Building 64 Room AB18K – AC-12]

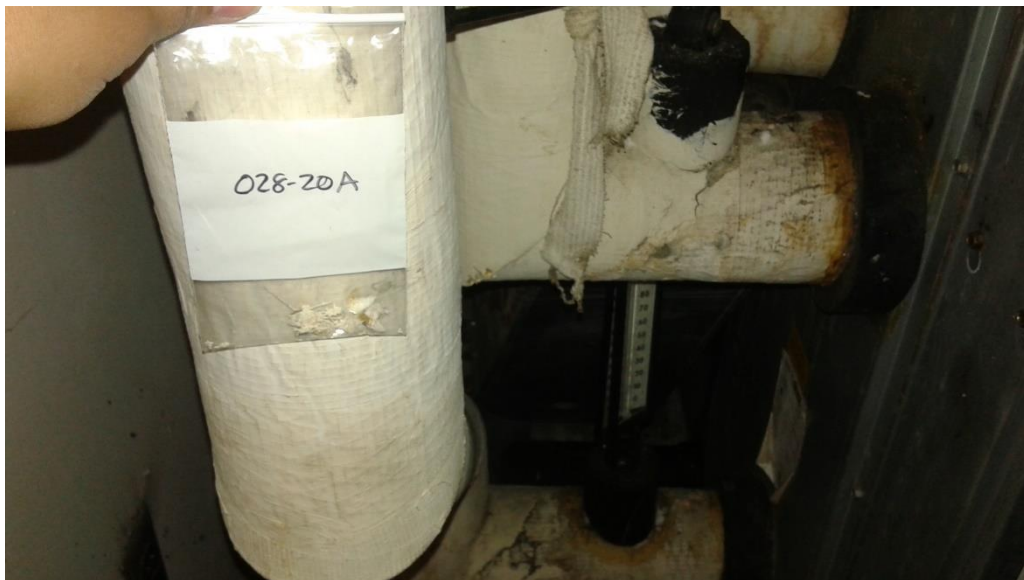
HSA-20

White mastic associated with foil paper wrap around water pipes
[Building 64 Room AB18K – AC-12]

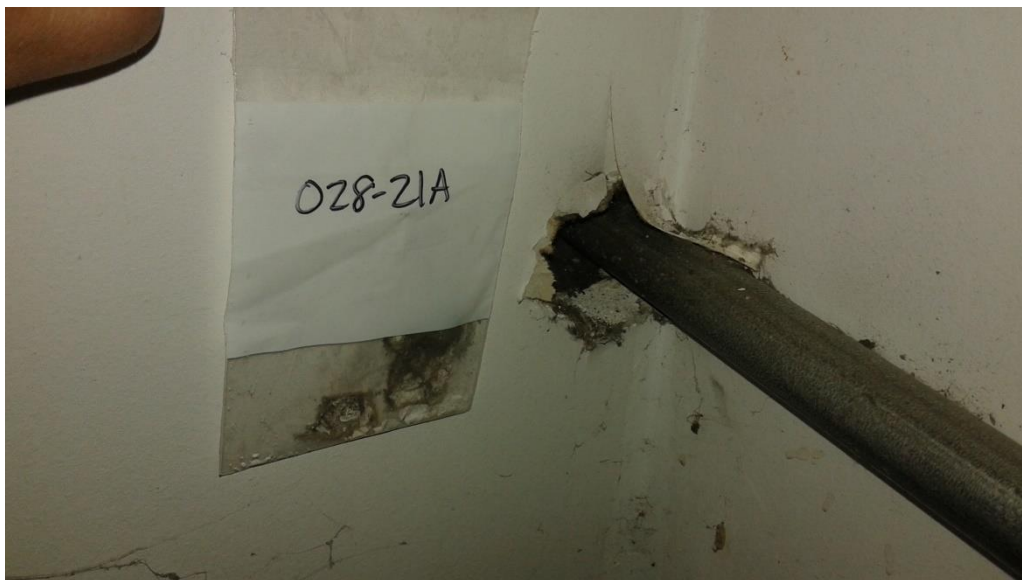
HSA-21

GWBS associated with joint compound
[Building 64 Room AB18K – AC-12]

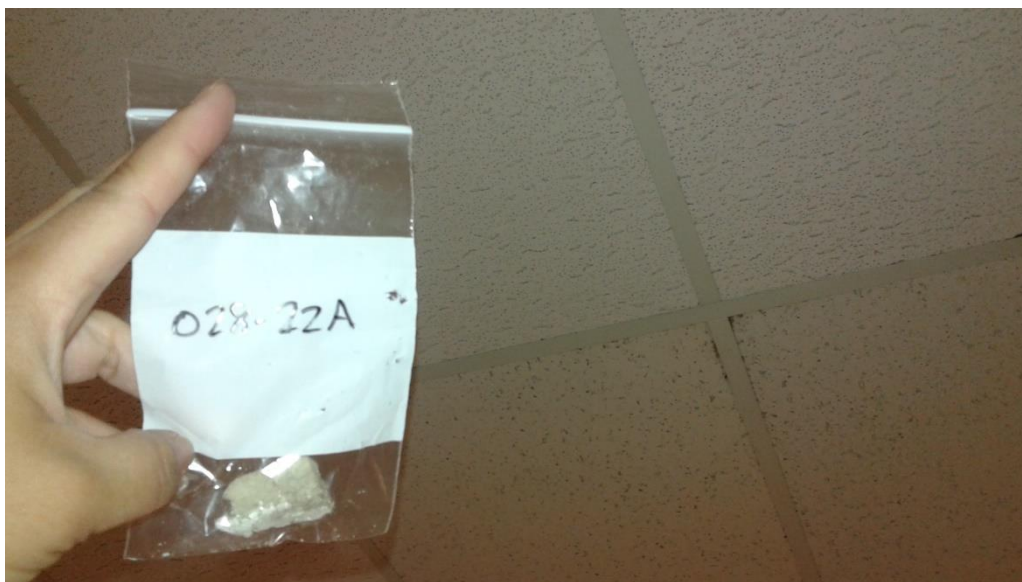
HSA-22

White 4x2 ceiling tiles throughout SPS in Building 64
[Building 64 Room AB28 (SPS)]

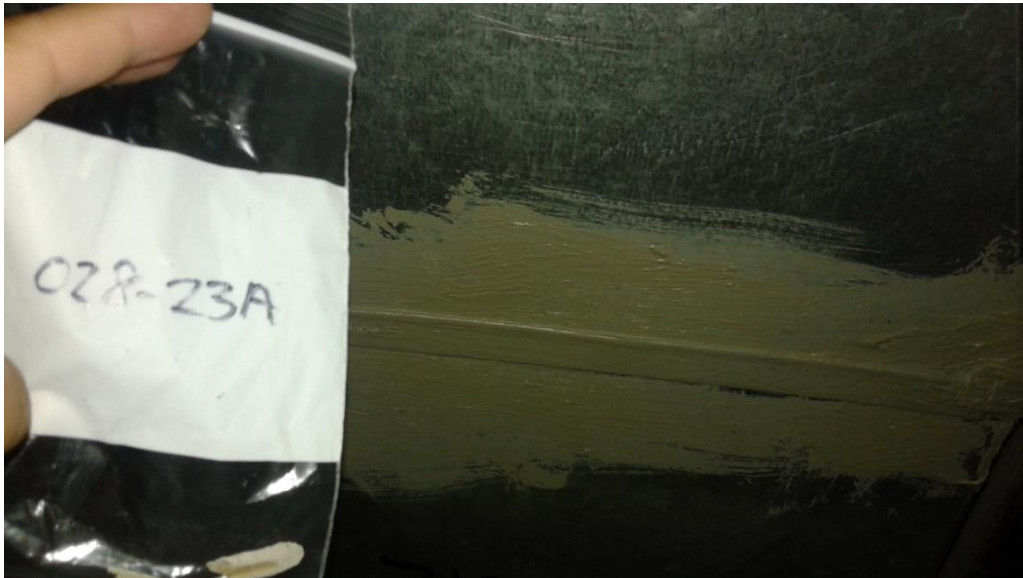
HSA-23

White mastic associated with metal ductwork throughout SPS in
Building 64 [Building 64 Room BB03 Hallway (SPS)]

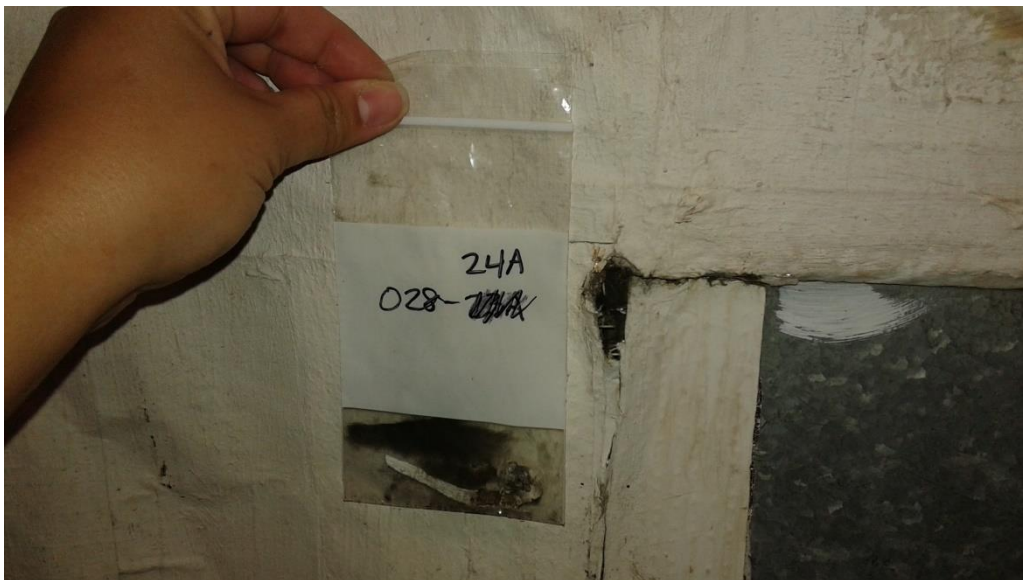
HSA-24

White mastic associated with foil paper and black insulation on AHU
[Building 64 Room AB30 – AC-1]

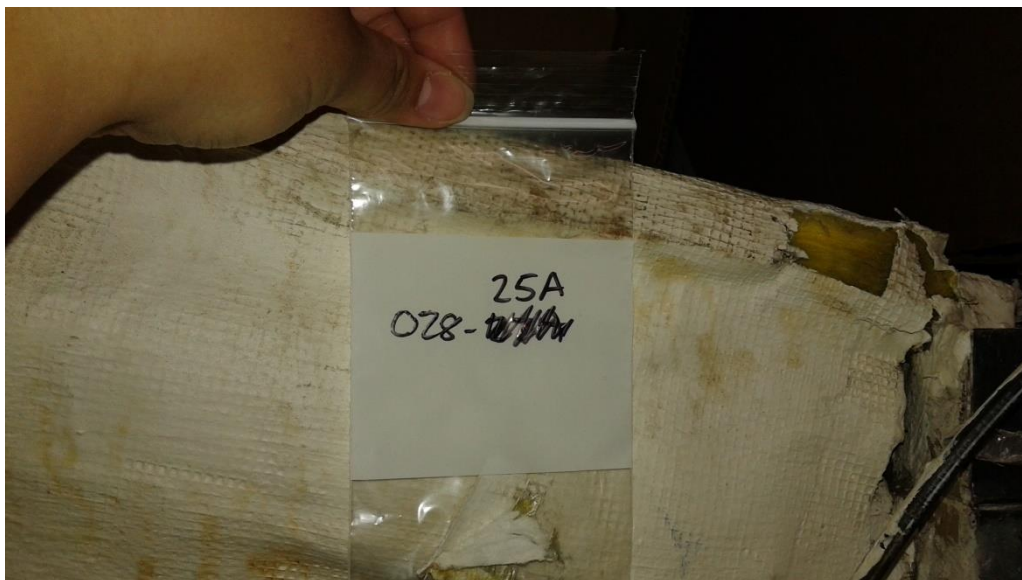
HSA-25

White mastic associated with foil paper and yellow insulation on AHU
[Building 64 Room AB30 – AC-1]

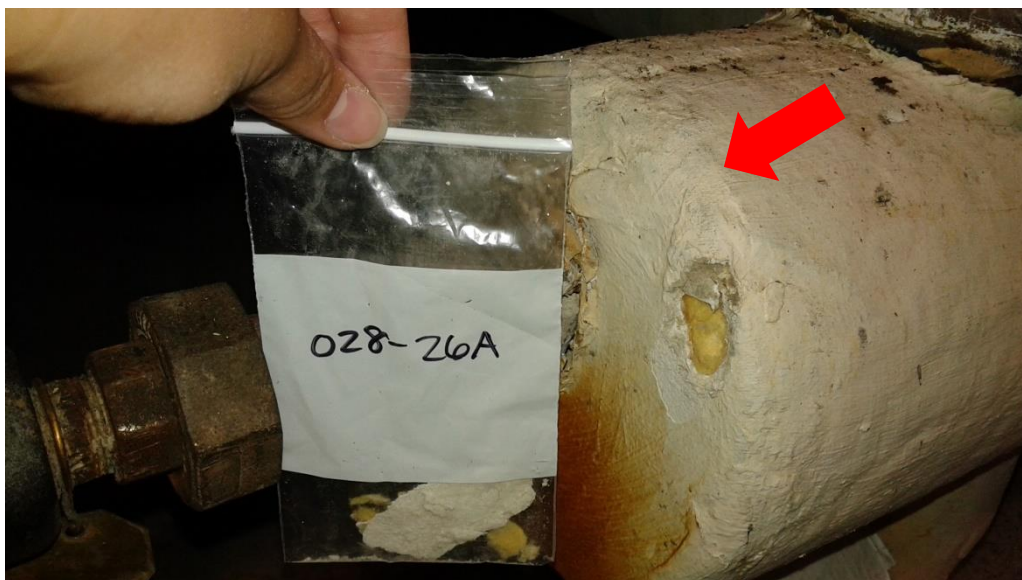
HSA-26

White mastic associated with AHU water pipe
[Building 64 Room AB30 – AC-1]

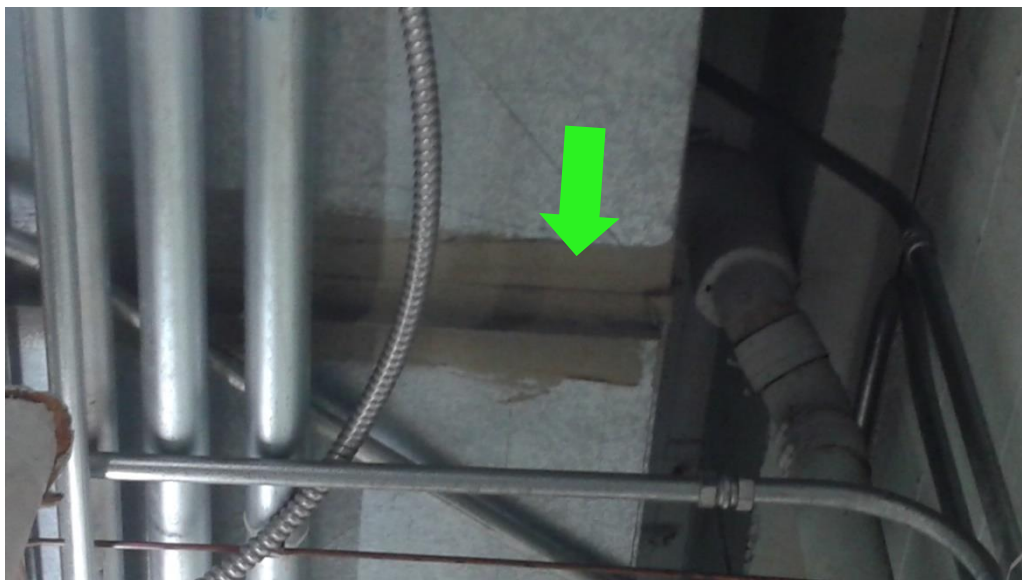
HSA-27

Light brown mastic on metal ductwork
[Building 64 Room AB30 – AC-1]

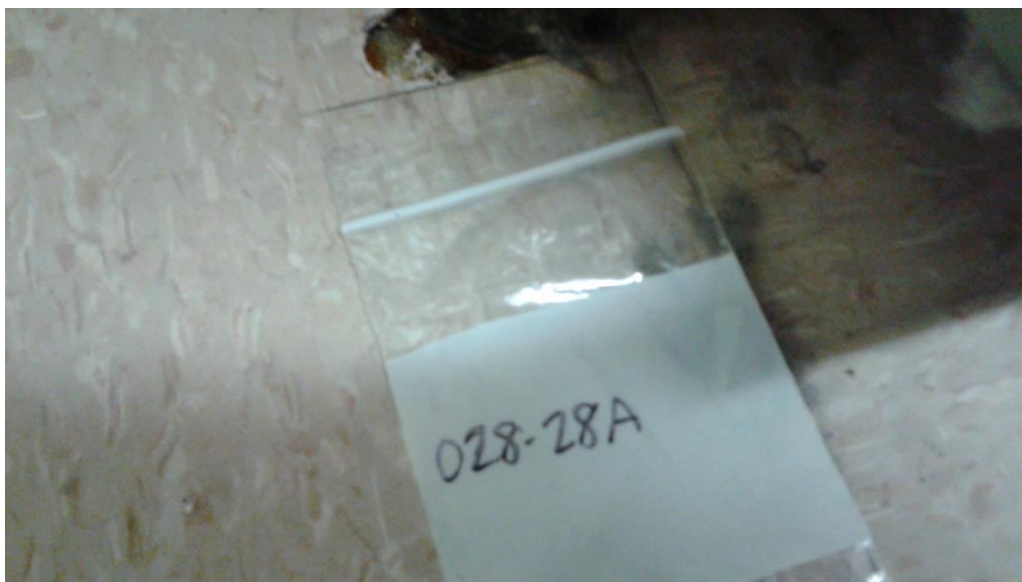
HSA-28

Pink 12x12 vinyl floor tile associated with yellow mastic
[Building 64 Room B118]

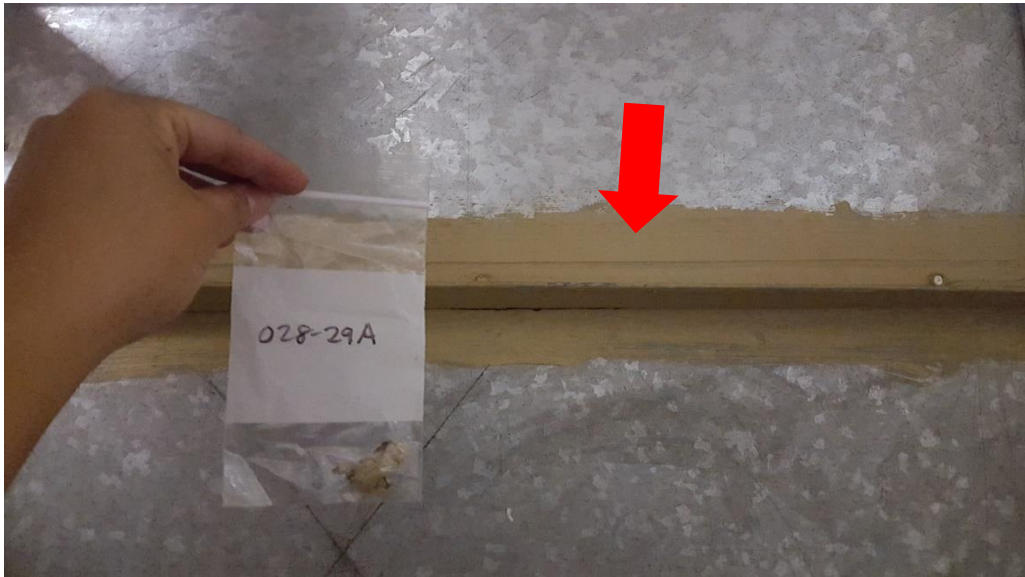
HSA-29
Light brown mastic on metal ductwork
[Building 64 Penthouse B – AC-53]

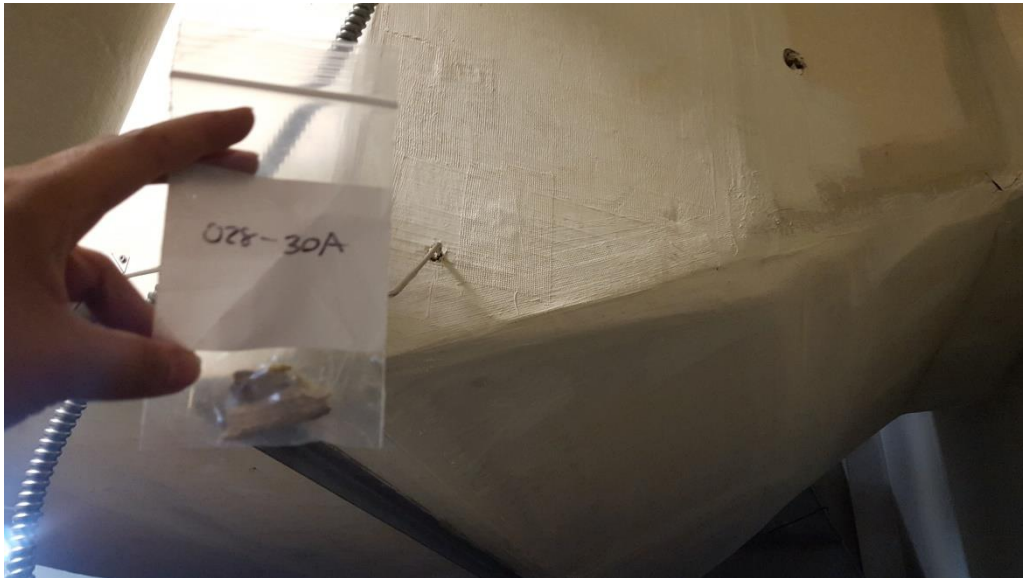
HSA-30

White mastic associated with foil paper wrap & yellow fiberglass insulation [Building 64 Penthouse B – AC-53]

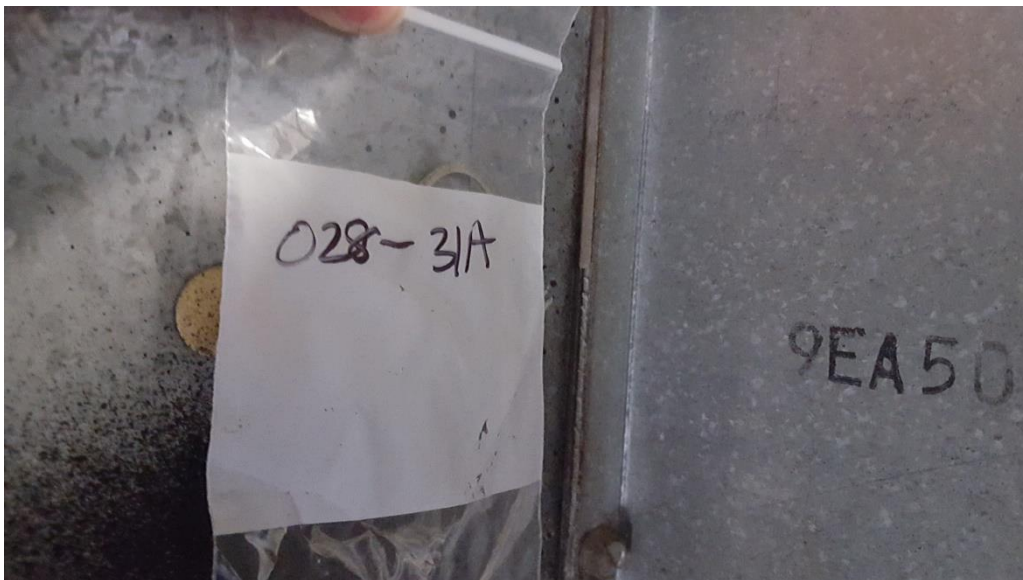
HSA-31

Grey caulk around AHU cover
[Building 64 Penthouse B – AC-53]

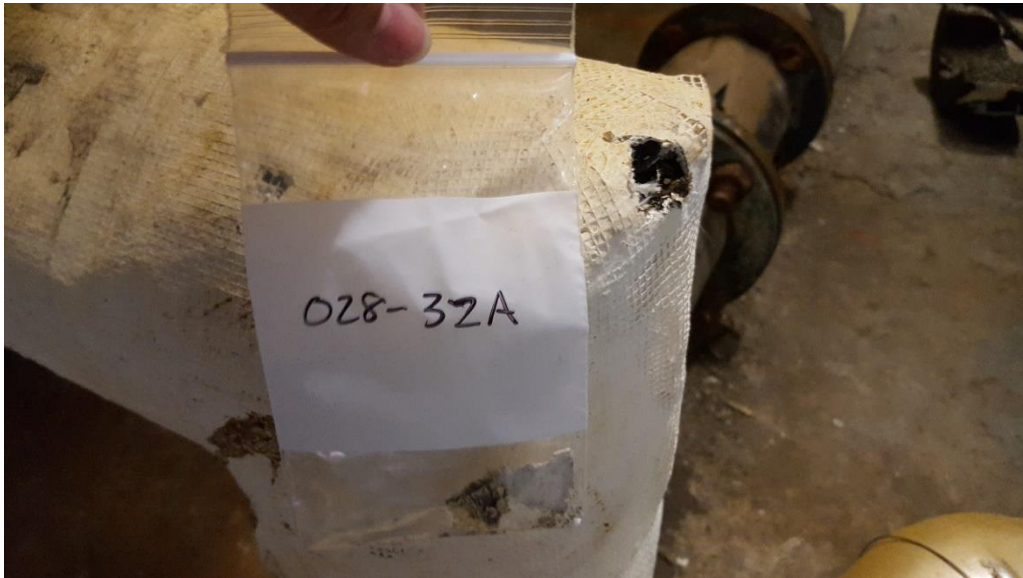
HSA-32

White mastic associated with stink rock around chilled water pipes
[Building 64 Penthouse B – AC-53]

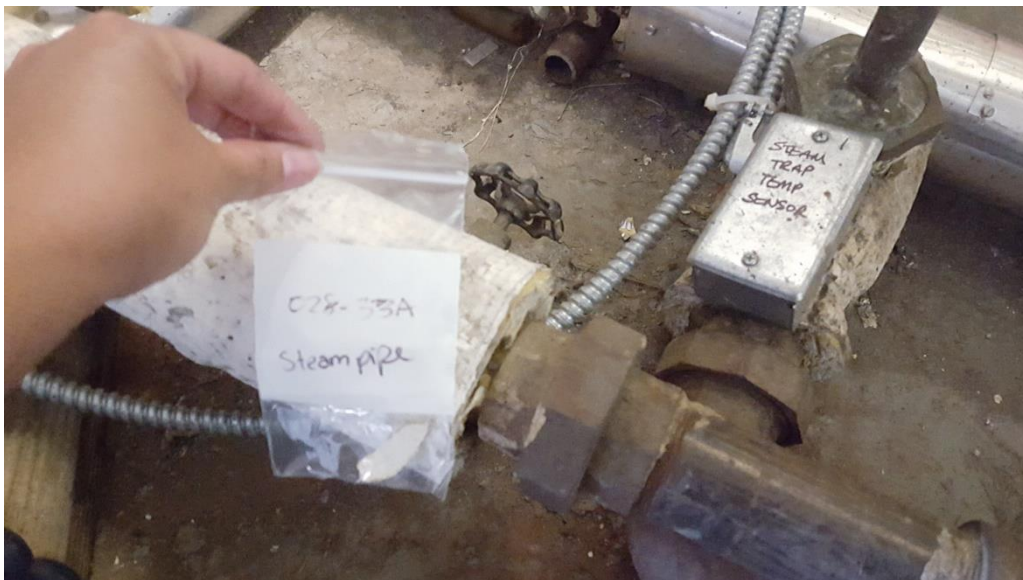
HSA-33

White mastic associated with foil paper wrap & yellow fiberglass insulation [Building 64 Penthouse B – AC-53]

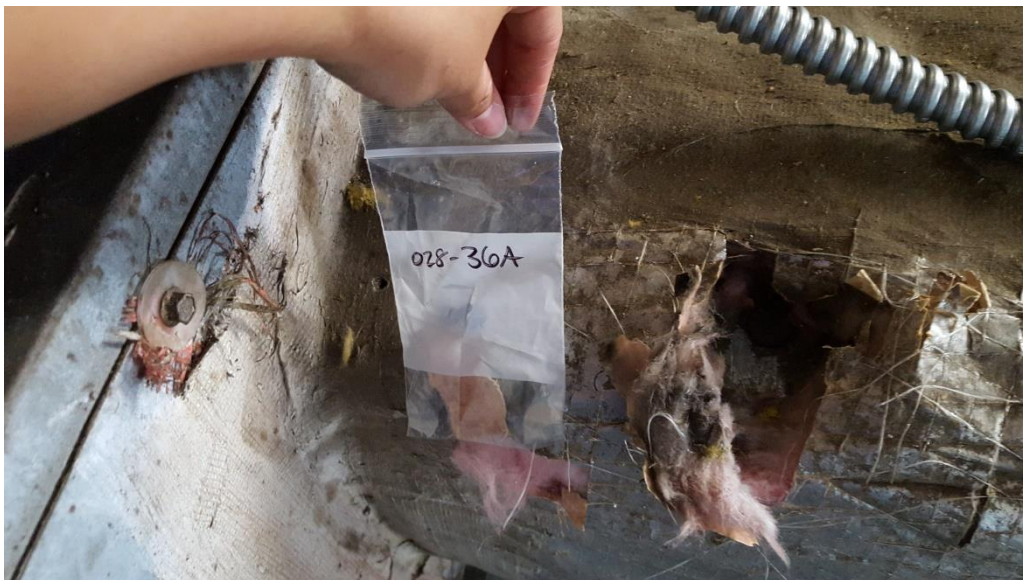
HSA-36

Foil paper wrap associated with pink fiberglass insulation & black mastic [Building 64 Penthouse A – AC-55]

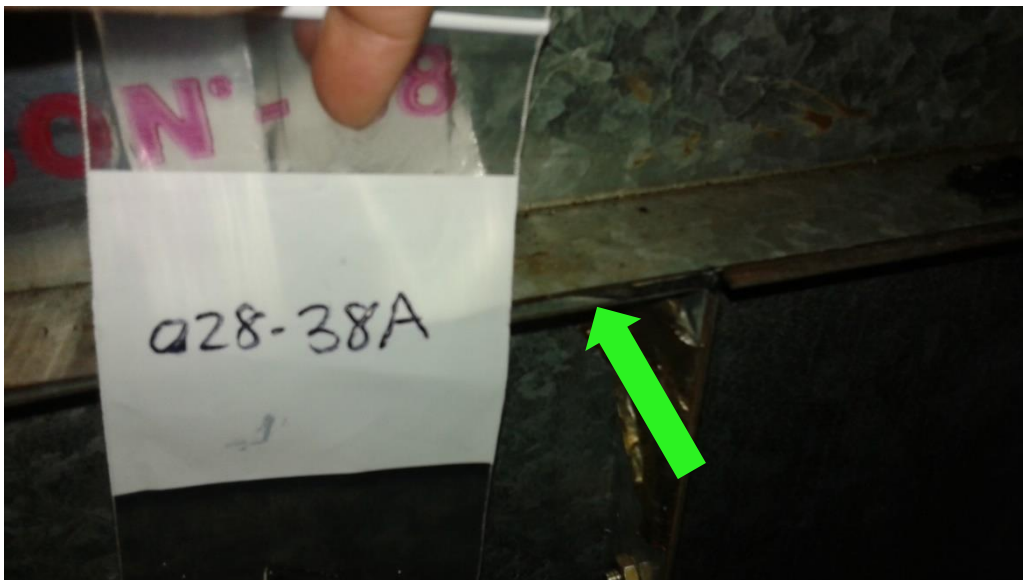
HSA-38

Black gasket between metal panels on AHU
[Building 19 B9A – AC-6]

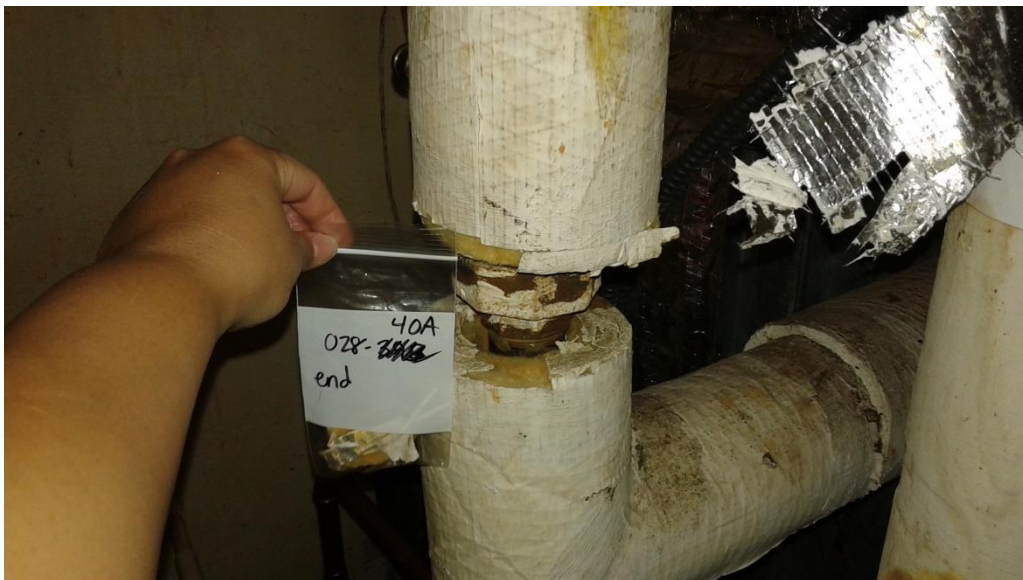
HSA-40

White mastic associated with yellow fiberglass insulation on steam pipe
[Building 19 B9A – AC-6]

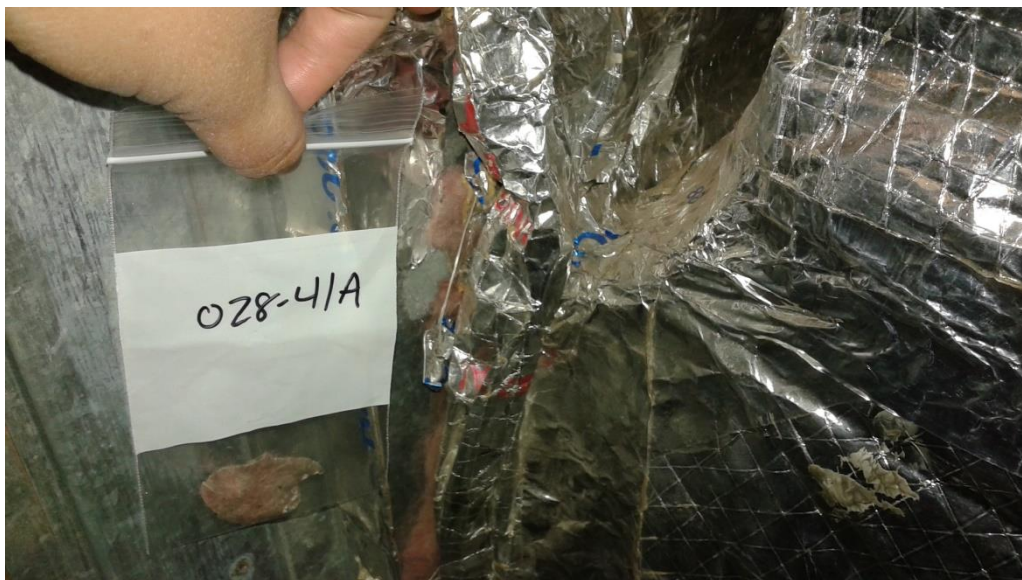
HSA-41

Gray mastic between metal ductwork and insulation
[Building 19 B9A – AC-6]
